I.S. Triad production batch 1 yield issues.

Order shipped 8.29.2024, consisting of 40 boards on 10 panels had 16 serious defects resulting in a loss of function.

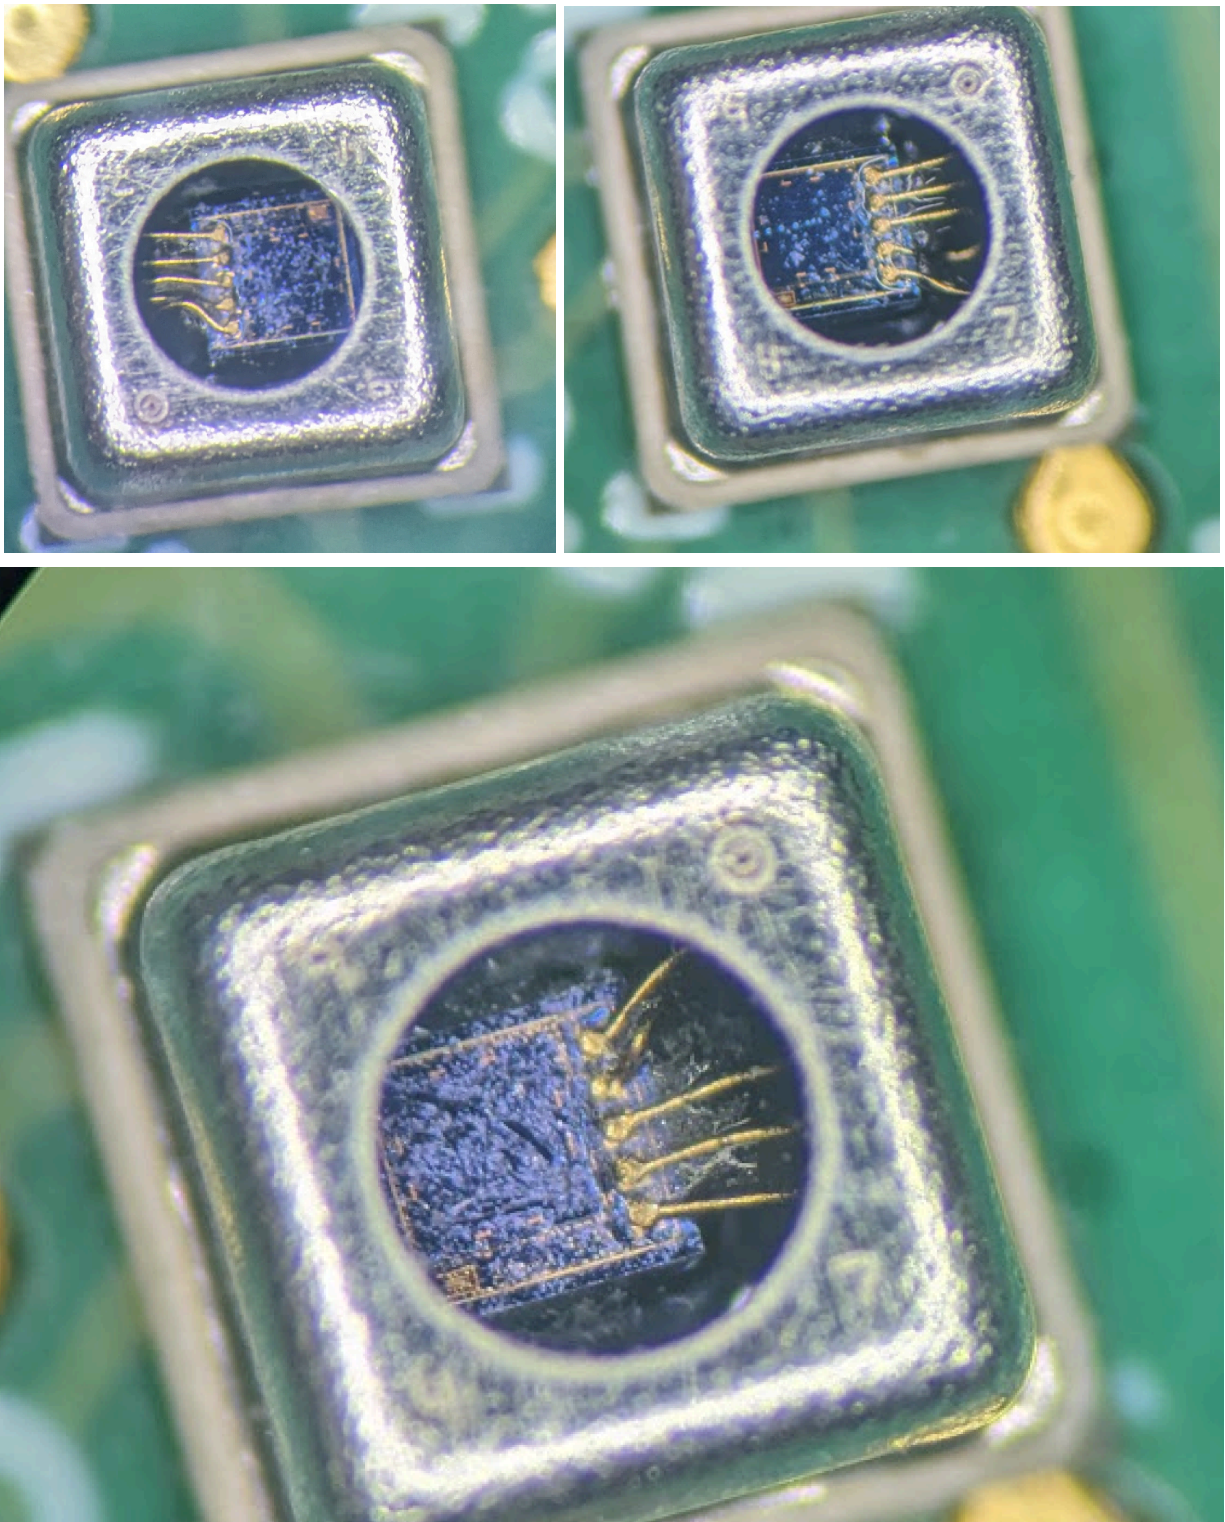
- 1) Issue 1: Barometric pressure sensor damage:
13 boards (serial numbers 18,19,20,35,75,82,83,84,85,87,217,219,220) had damaged barometers.
The damage is consistent with a failure of the masking on the barometer during cleaning. See images below.

Figure 2 Damaged barometers (sns 82-84)

- 1) Identify the root cause of the inconsistent masking performance for the barometers and implement a mitigation. Perform 100% inspection either microscope assisted visual or x-ray to identify barometer damage until the mitigation is validated.
- 2) Amend the rear stencil/solder mask application procedure with similar modifications to those already implemented for the front stencil to ensure reliable joints of the rear DFN packages.
- 3) Resume staking the J3 connector to improve mechanical reliability.

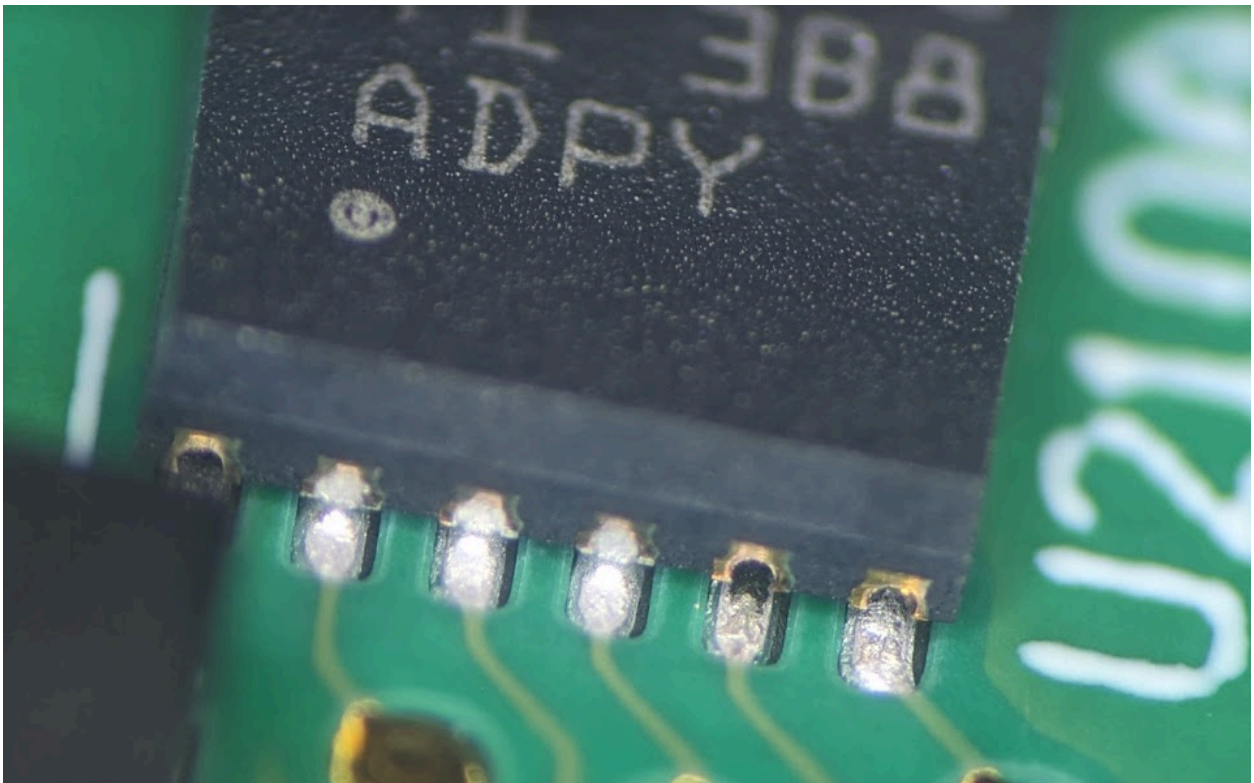
- 2) Issue 2: incomplete DFN package solder joints on the rear side of the PCBA (2 defects)
2 boards (serial number 19, 33.) Had incomplete joints on DFN packages, similar to the defects observed on the first articles. PCBA 19 has incomplete connections on U210A. PCBA 33 has incomplete connections on U11C.

Figure 3 serial # 19 U210A closeup showing no joint/incomplete fill on pins 1, 5, 6

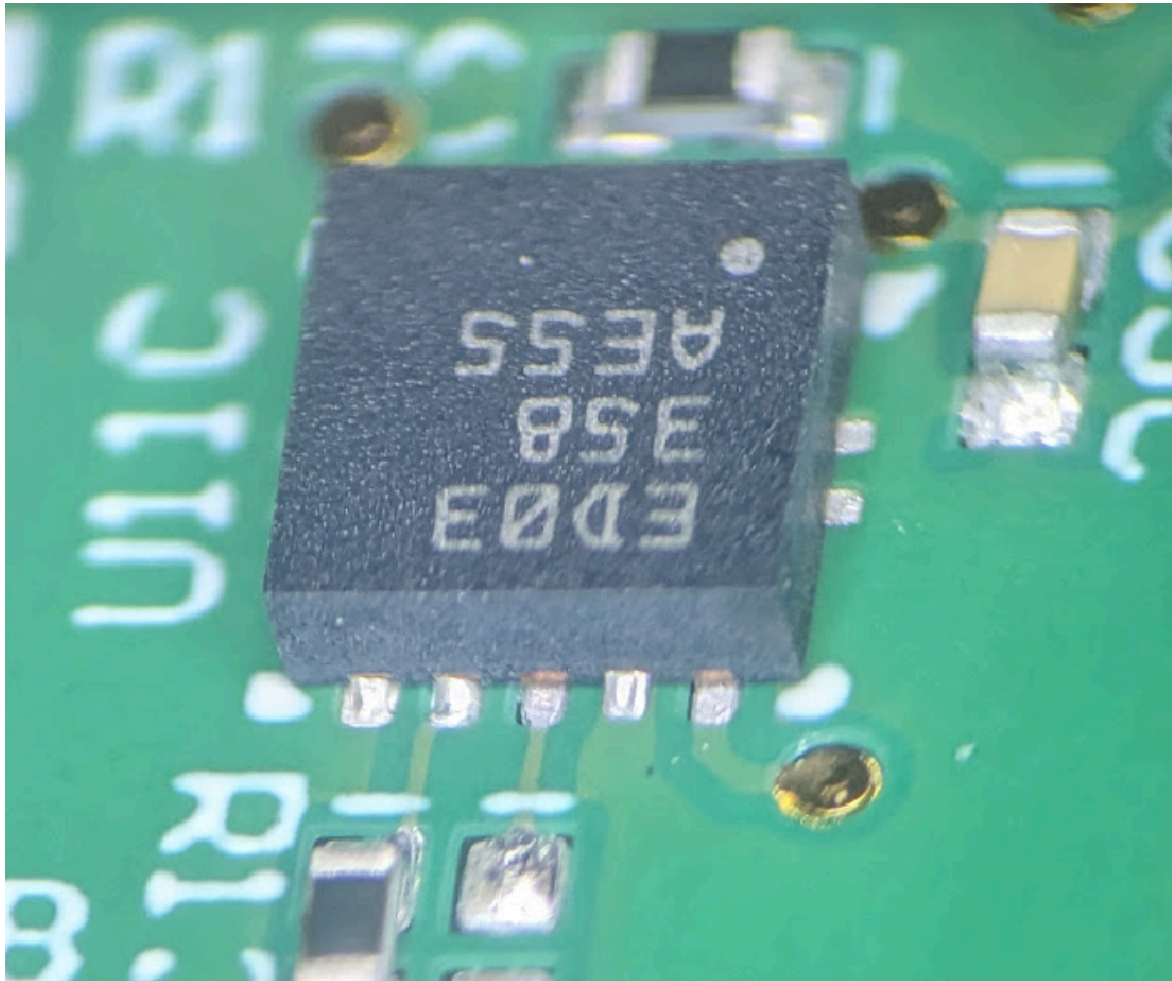
Figure 4 Incomplete joints on pins 8 and 10 on U11C (sn 33).

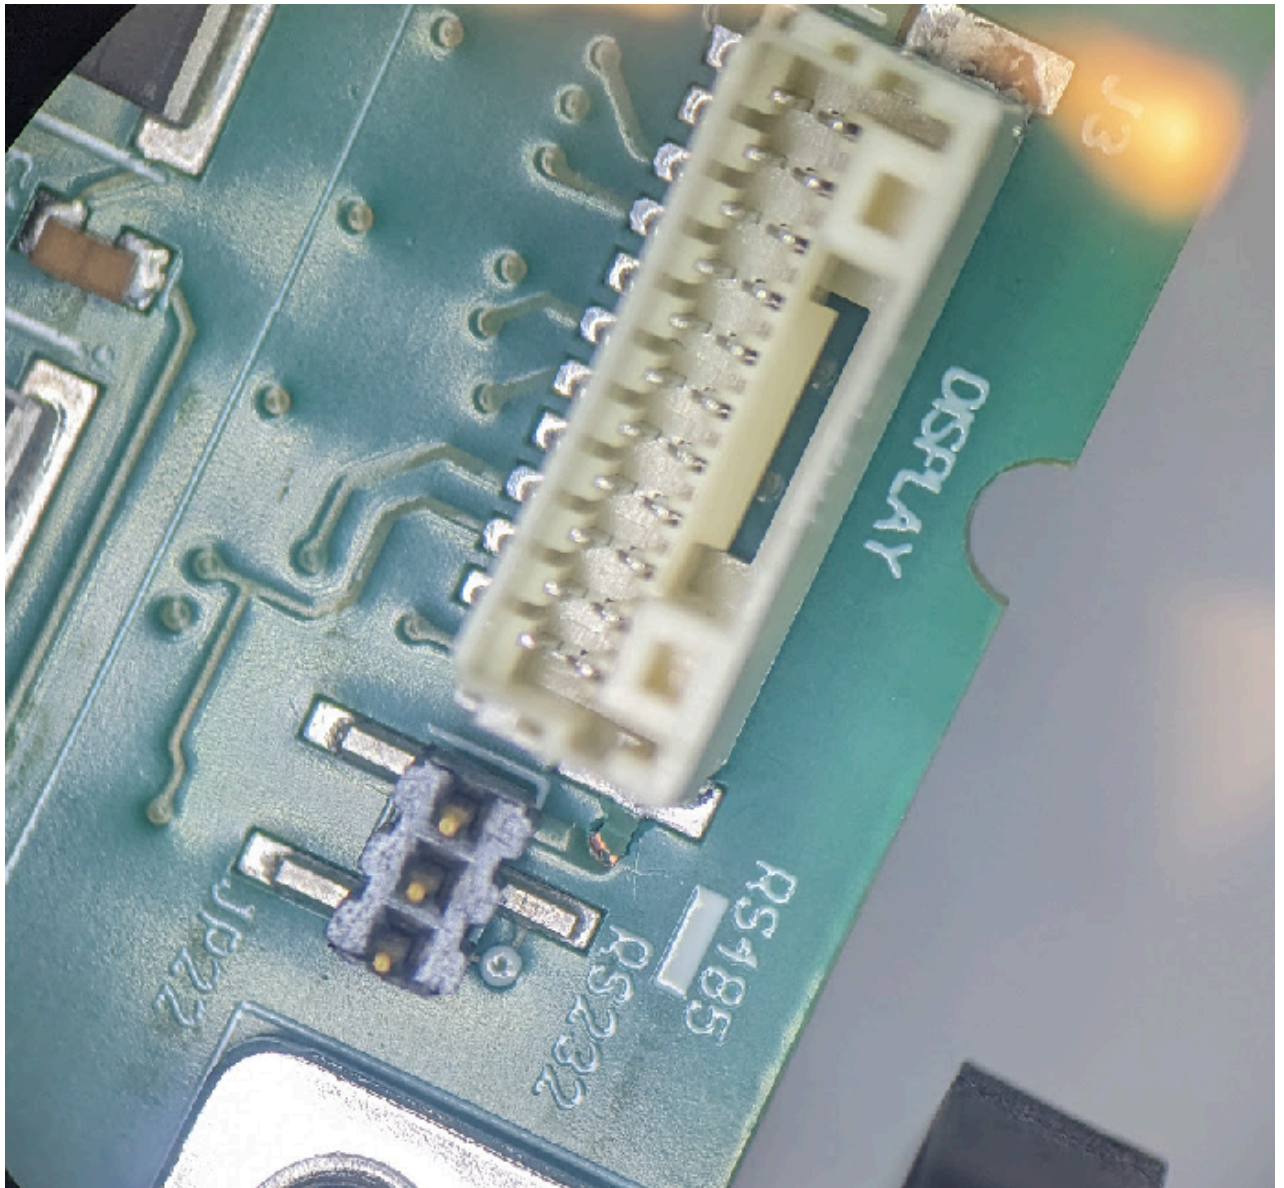
3) Issue 3: Handling damage to J3.

One PCBA showed a lifted pad and via associated with J3.
